## Trip report NOAA AOC

Date: July 18 to 22

1. Install the latest software drop which should fix radar and CfRadial issues.
2. Review aircraft faults (Moncal, TGTINJ and Noise figure)

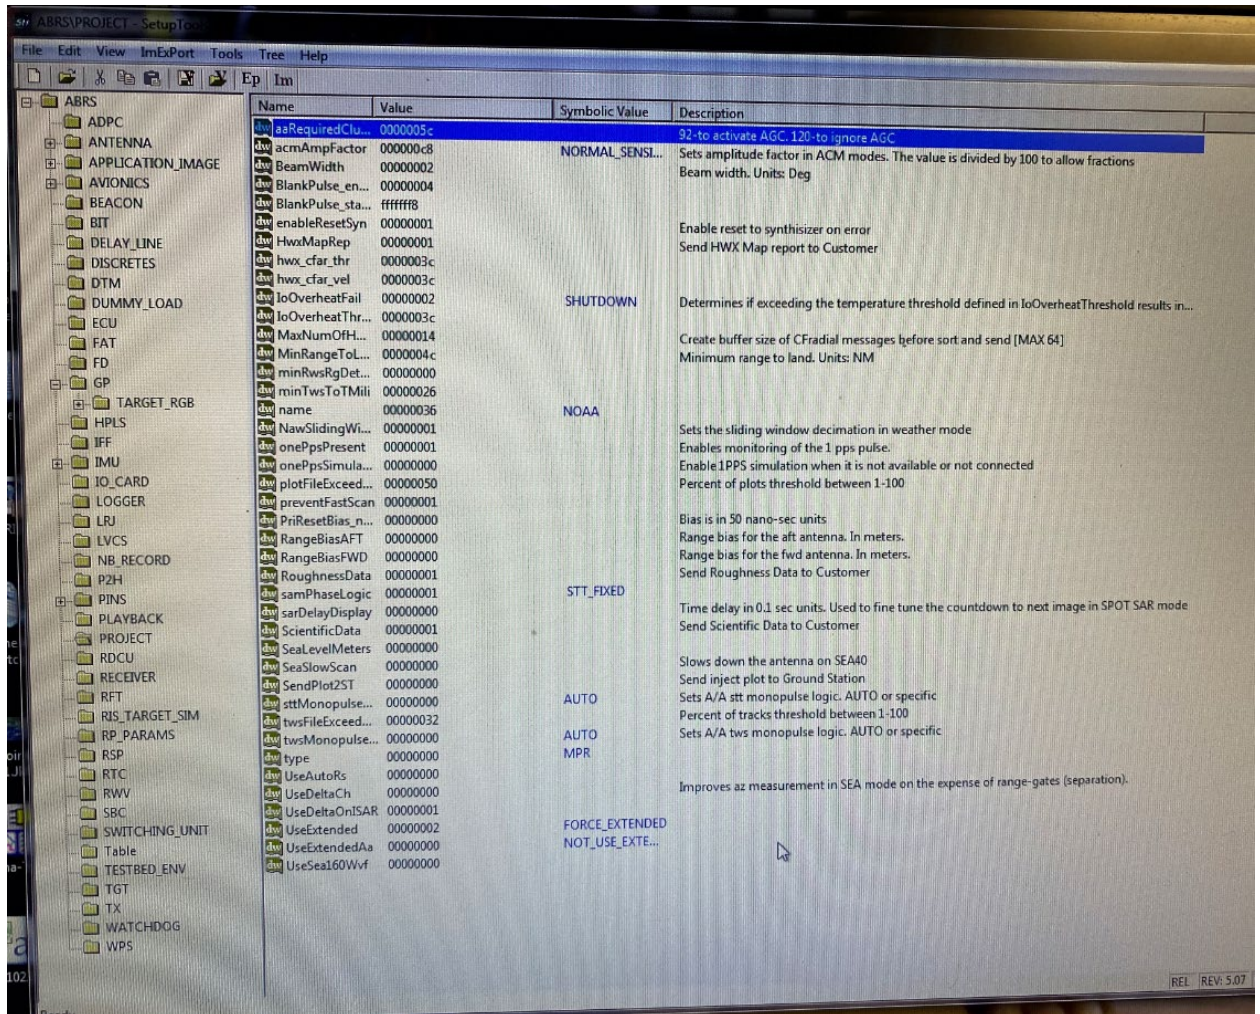
- 
- The Thresholds in the new SW drop "Version K" are low HWX\_CFAR\_THR should be 3C ,same for velocity

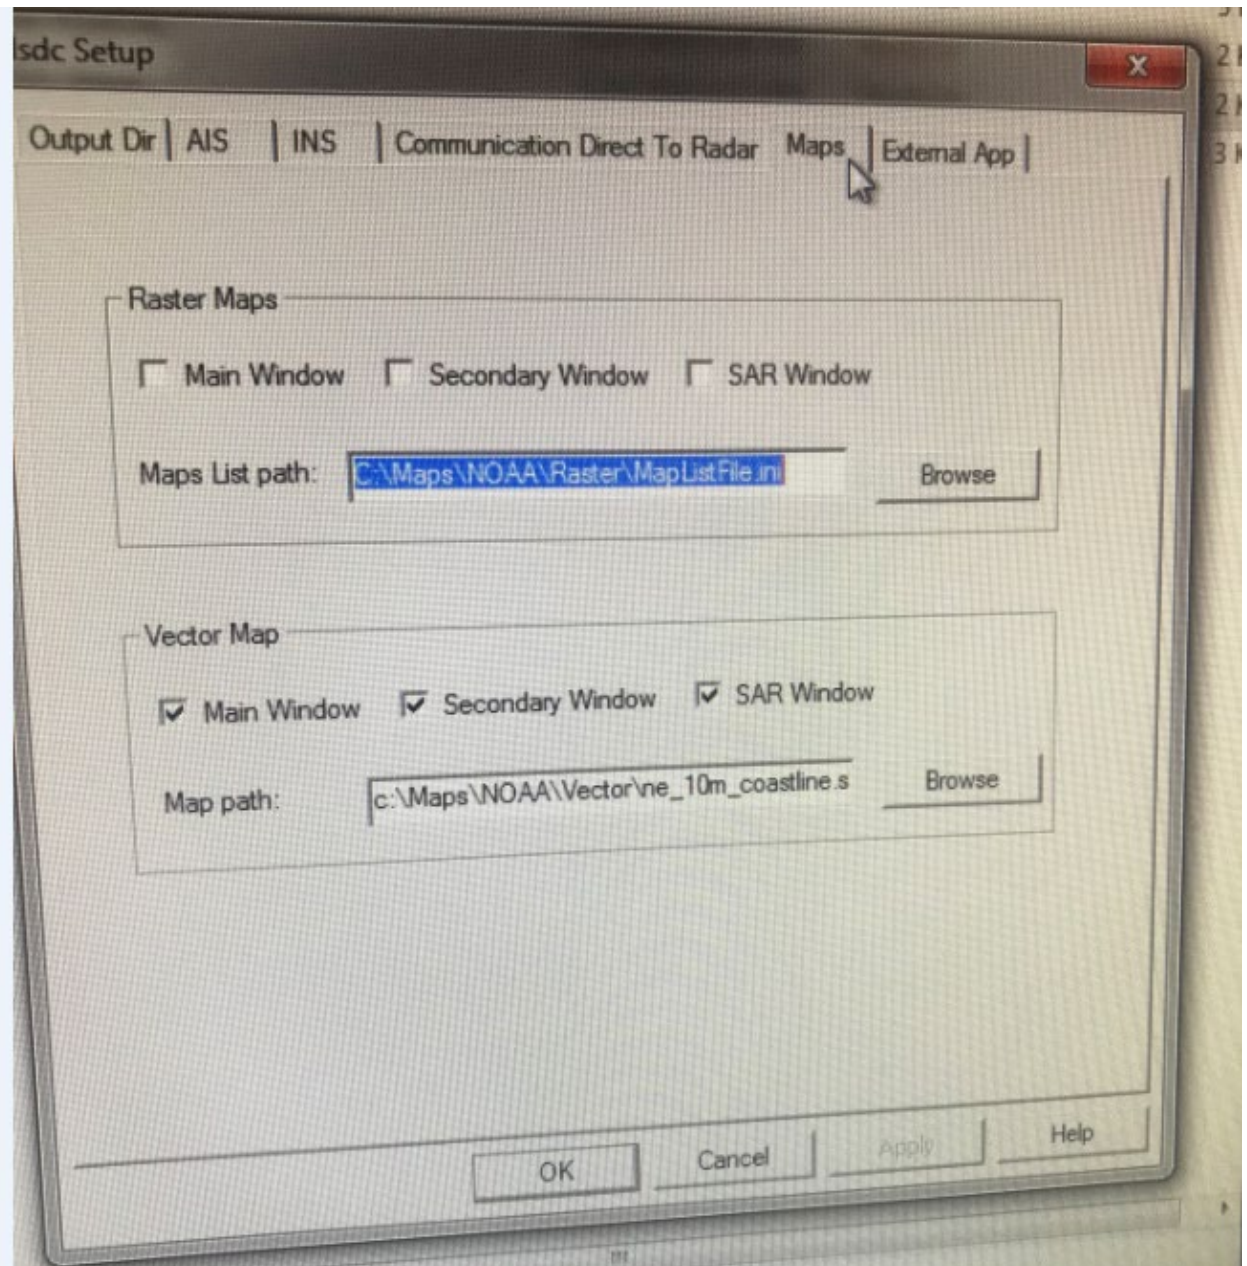
- 
- This is the forward MSDC setup with ".5" rear station on N43 was ".4" also all the checked boxes are not checked for the rear station.

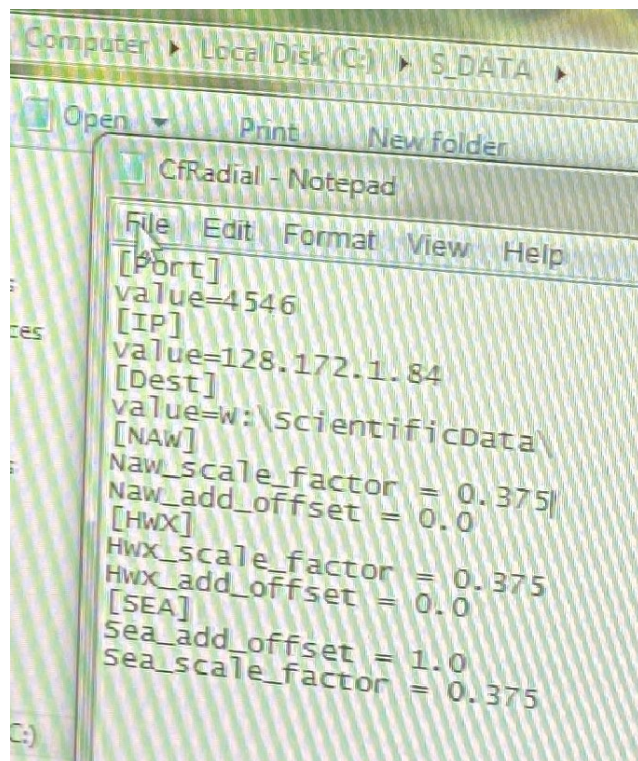
- The path to the S\_DATA CfRadial.ini file, Unchecked in the rear station
